Structural Evaluation of Riveted Spillway Gates

Final report

Prepared for U.S. Army Corps of Engineers
Washington, DC 20314-1000

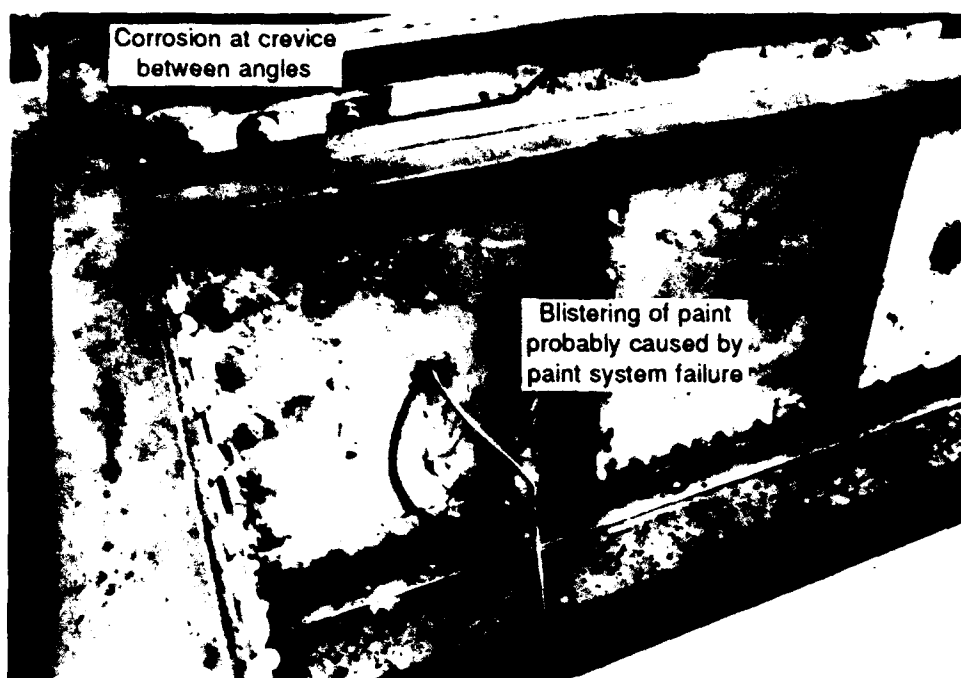
Figure 19. Vertical lift gate at Bankhead Lock and Dam with paint blistering and corrosion

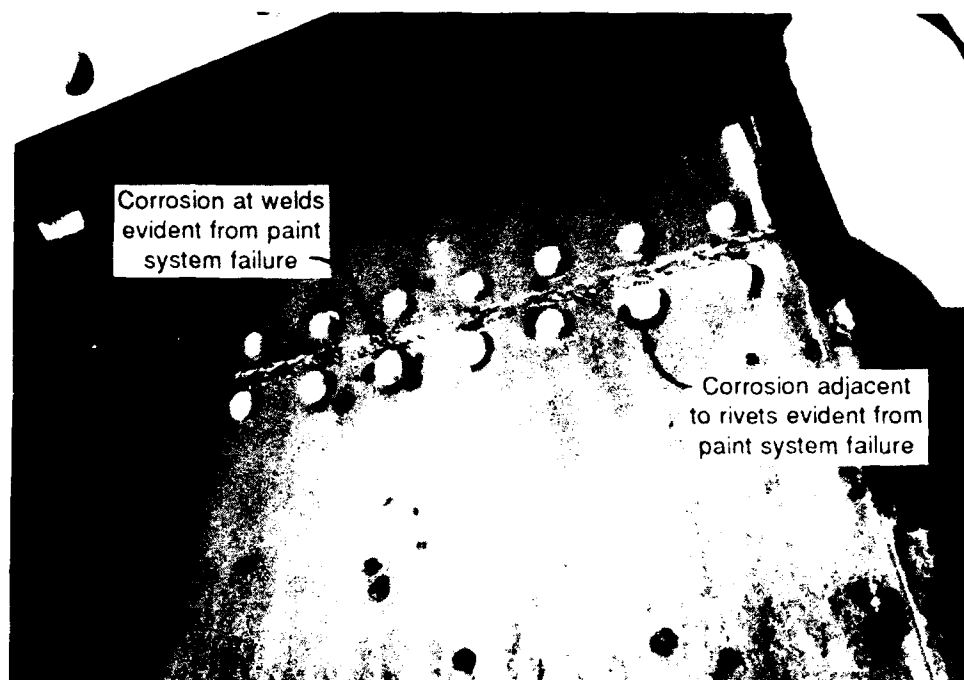
Figure 20. Tainter gate at Mississippi Lock and Dam No. 5 with seal weld and localized corrosion

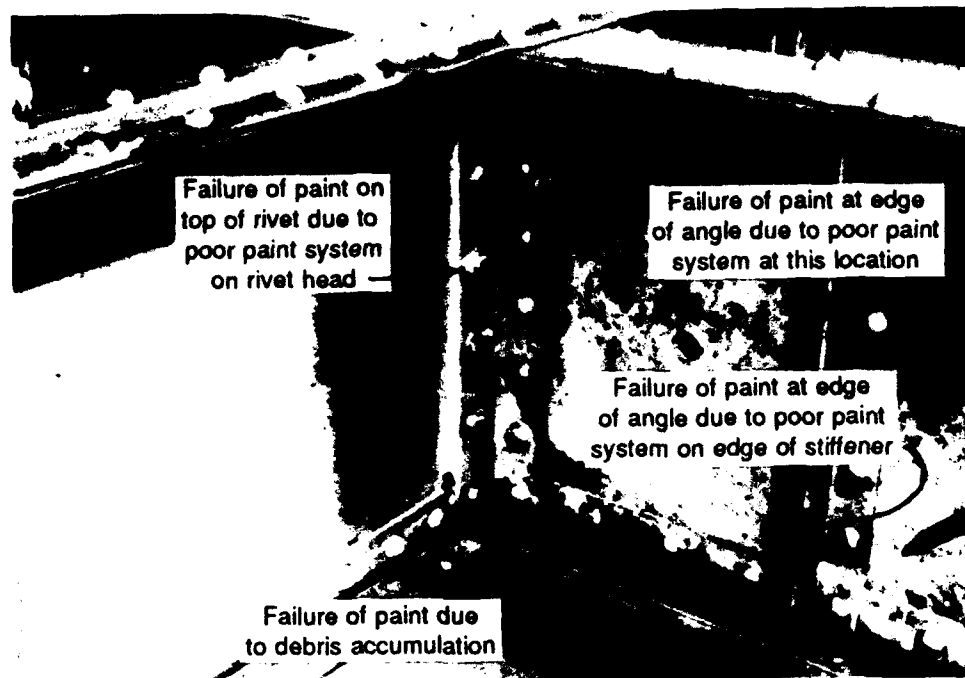
Figure 21. Vertical lift gate at Bankhead Lock and Dam with crevice corrosion, corrosion at edges, and corrosion on rivet heads

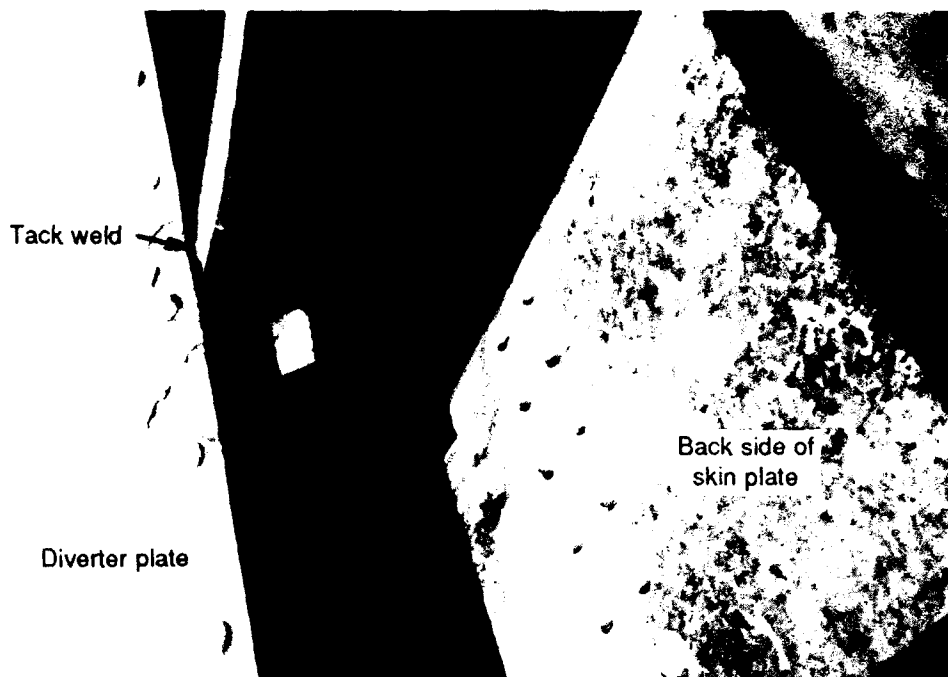
Figure 22. Failure of paint system on tainter gate at edge of plate near tack weld, Mississippi Lock and Dam No. 9

Surface pretreatment including adequate cleaning is necessary for the transition zone and the area to be repainted.

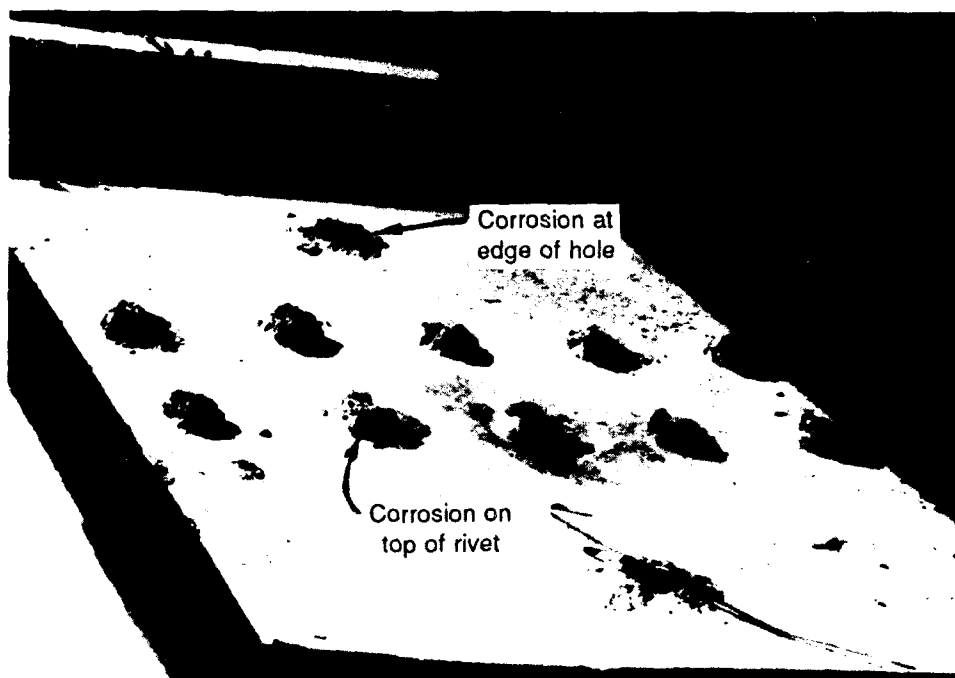
Figure 23. Vertical lift gate at Bankhead Lock and Dam with corrosion of rivet heads

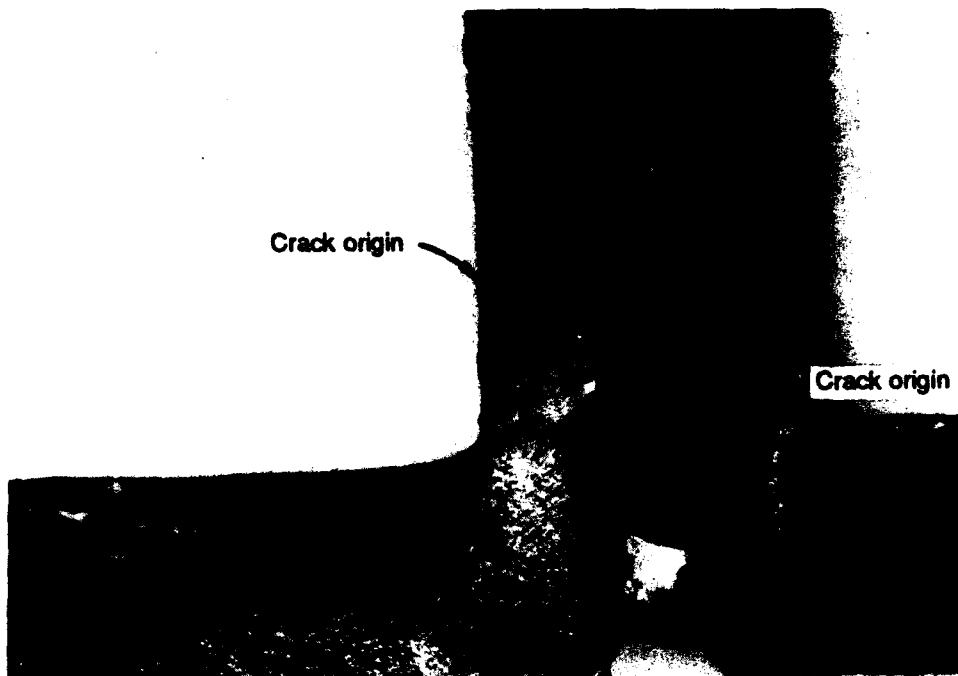
Figure 26. Crack surface at the edge of a rivet hole

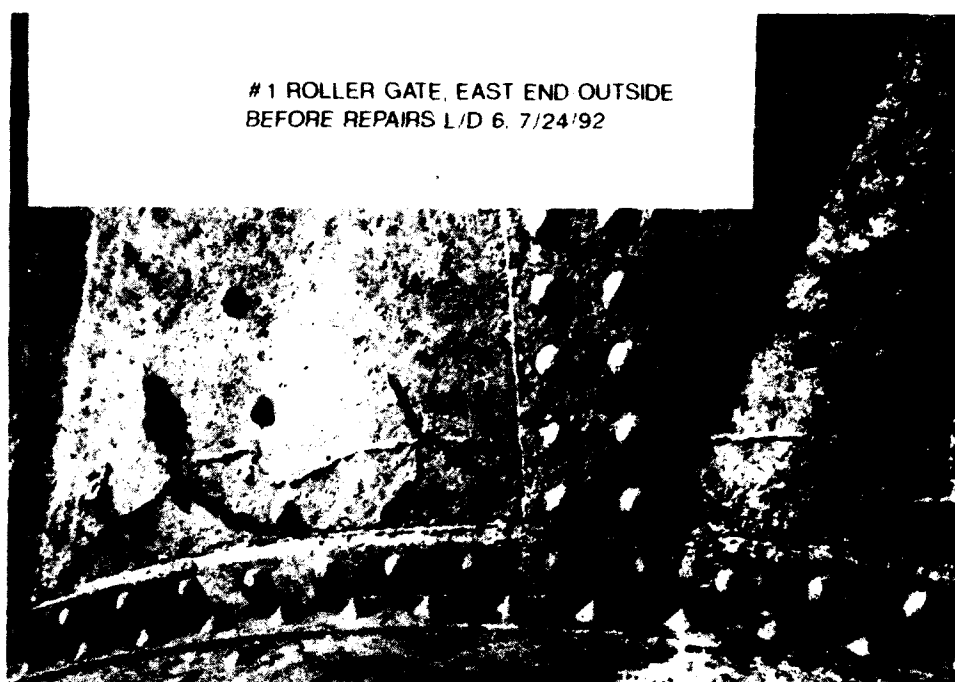
b. Fatigue cracks redeveloped at previous repair welds

Dam No. 6 in the St. Paul District.¹ Figure 32b indicates cracks reinitiating from previous repair welds. In this instance, attempts to strengthen a riveted gate by adding welded stiffening plates created very poor fatigue details. Repairs such as this should be avoided. Figure 33 shows a fatigue crack starting from a tack weld on a riveted bridge member. The crack initiated at the toe of the tack weld and grew into the riveted plate in the direction perpendicular to the primary tensile stress. Similar damage could occur on a riveted gate member.
